## Chalmers Properties

## Asbestos Assessment

### 54 Fryatt Street, Port Chalmers, Dunedin

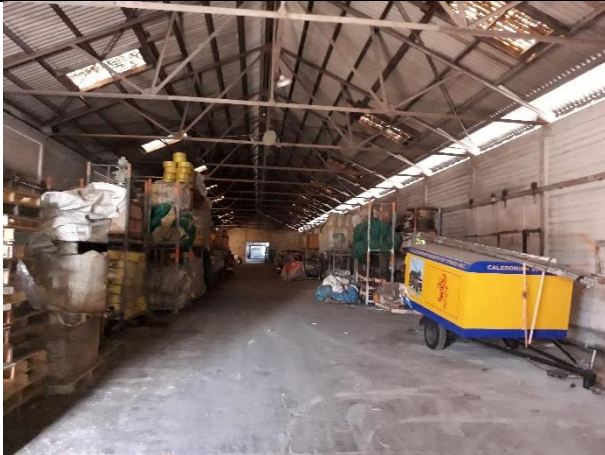
Interior of Qa Shed

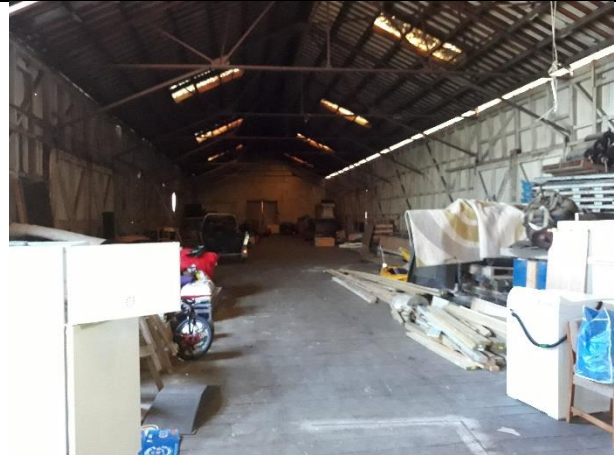
Interior of R Shed

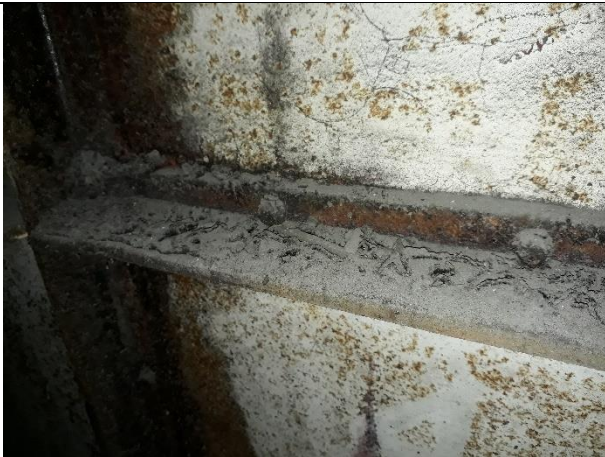
Dust on internal door ledges

- Removal of the super six roof is recommended
- If removal is not practical the roof and soil should be encapsulated with a semi-permanent solution that should be regularly inspected
- Following removal or encapsulation the interior of the buildings will need to be decontaminated

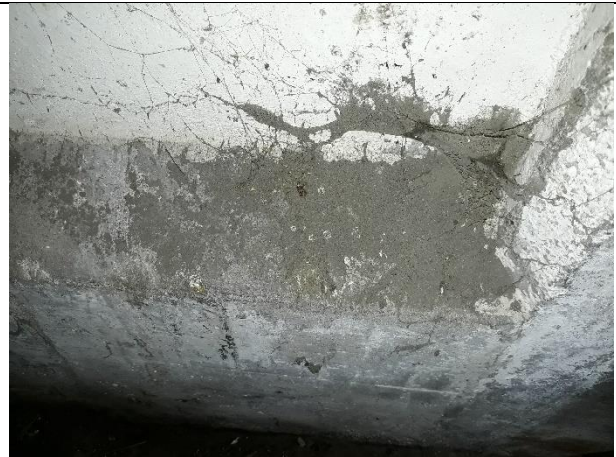
Dust on internal wall ledges

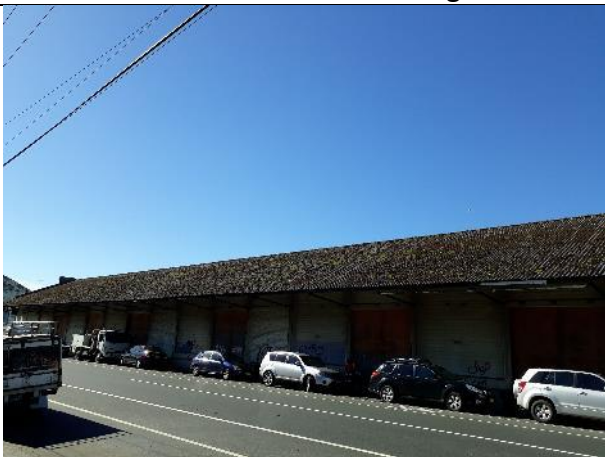
Exterior of R Shed  
Cars parked under the roof overhang

- The area below and around the building need to be treated as contaminated soil.
- The results of the monitoring should be made available to the building's immediate neighbours
- Access to the wharf should be restricted
- Signage indicating the hazard should be installed
- Parking on the street next to the buildings should not be allowed. This may require consultation with the local council

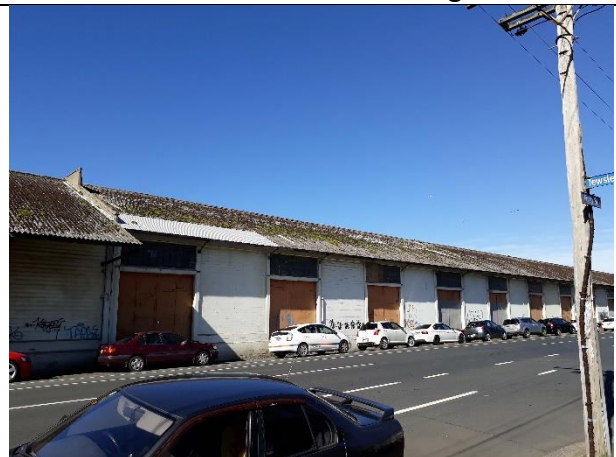
Exterior of Px Shed  
Cars parked under the roof overhang

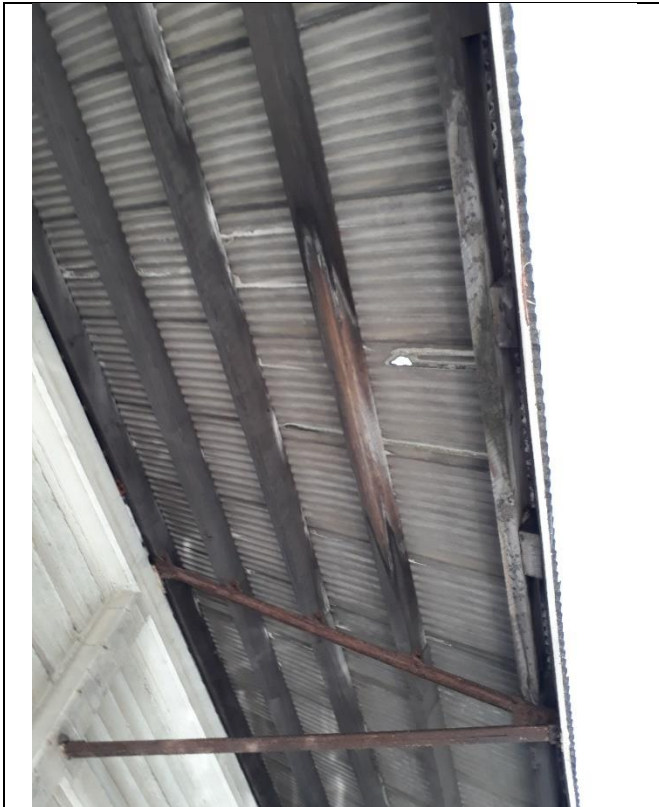
Super six roof overhang seen from below  
Water marks, holes and damaged edges are easily visible

- Gutters with down pipes should be installed on the street side of the buildings under the roof. Care must be taken to ensure the roof is not damaged during this process
- The gutters and down pipes on the sea side should be cleared and inspected to ensure they do not leak
- The roof and soil should be sealed with an adhesive if the long-term actions below cannot be completed within 3 months

- Removal of the super six roof and contaminated soil is recommended
- If removal is not practical the roof and soil should be encapsulated with a semi-permanent solution as the adhesive is a short-term solution which is prone to weathering
- Following removal or encapsulation the interior of the buildings will need to be decontaminated

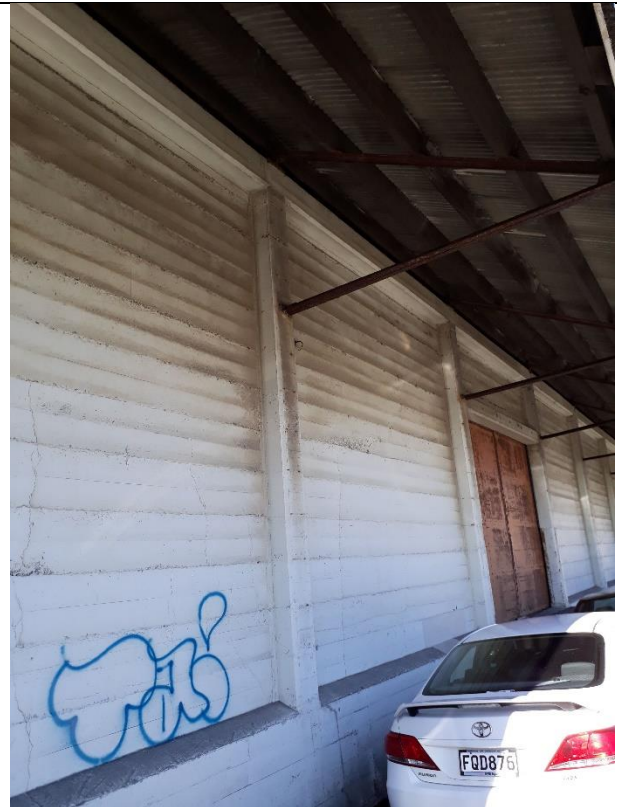
Dust gathered on an exterior wall

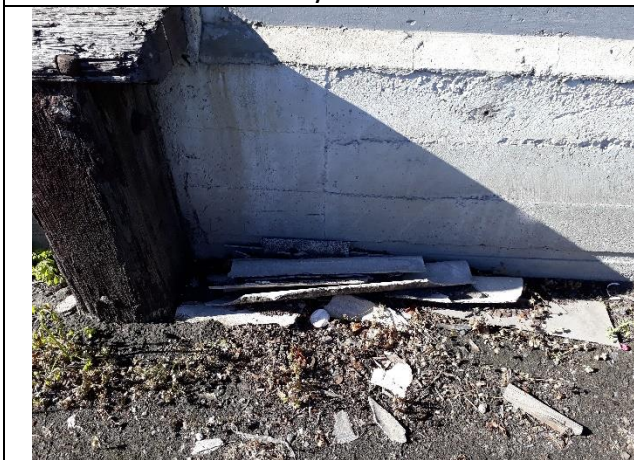
Super six fragments dumped in a pile

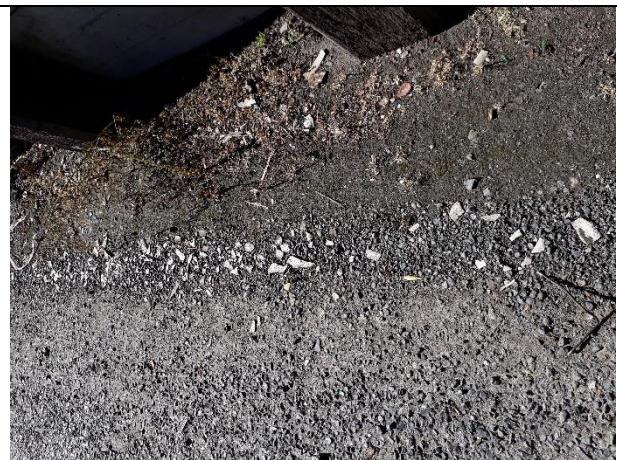
Super six fragments along the ground
